Murphy Aircraft mfg. ltd.
 Unit 1, 8155 Aitken Road,
 Chilliwack, British Columbia, Canada
 V2R 4H5
 Tel: (604) 792-5855
 Fax: (604) 792-7006

Technical Bulletin

October 3, 1997
Chilliwack, British Columbia

Attention: Elite customers and Rebel customers with split Flap/Aileron Retro kits only.
Subject: Flap-3 and Flap-9

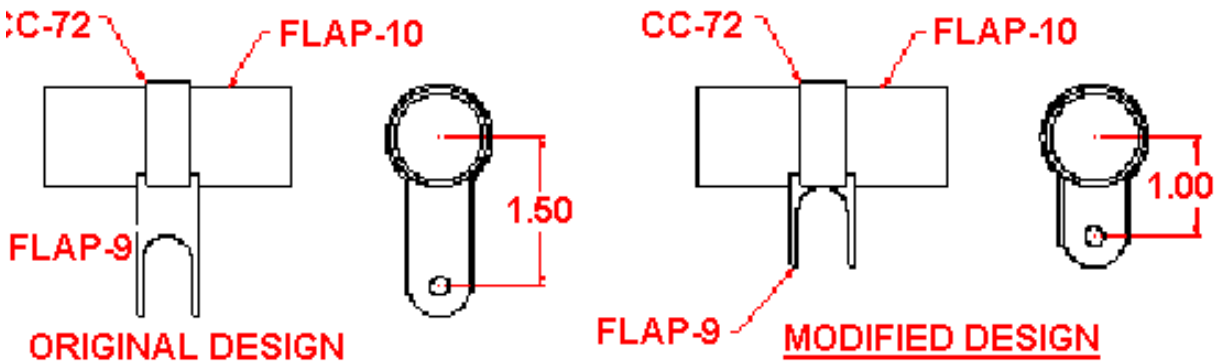
Flap-9 Horn and Flap-3 Aileron-Flap Horn Assembly have been modified as per the figures shown below. We believe that everyone affected is aware of the change and has received modified parts or are making the required changes themselves. The centre to centre distance has been reduced from 1 1/2" to 1". This change was made to reduce the amount of droop in the ailerons when the flaps were applied. This improves aileron response at full flaps.

We are posting this message to ensure that everyone affected is indeed aware of the changes. If for some reason you have received an unmodified assembly and were not contacted please let us know so that we can remedy the situation.
