**Murphy Aircraft mfg. ltd.**  
Unit 1, 8155 Aitken Road,  
Chilliwack, British Columbia, Canada  
V2R 4H5

## **Technical Bulletin**

**September 29, 1997**  
**Chilliwack, British Columbia**

**Attention:** Rebel and Elite Owners with Spring Gear  
**Subject:** Inboard Spring Gear Bolt (AN6-45A)

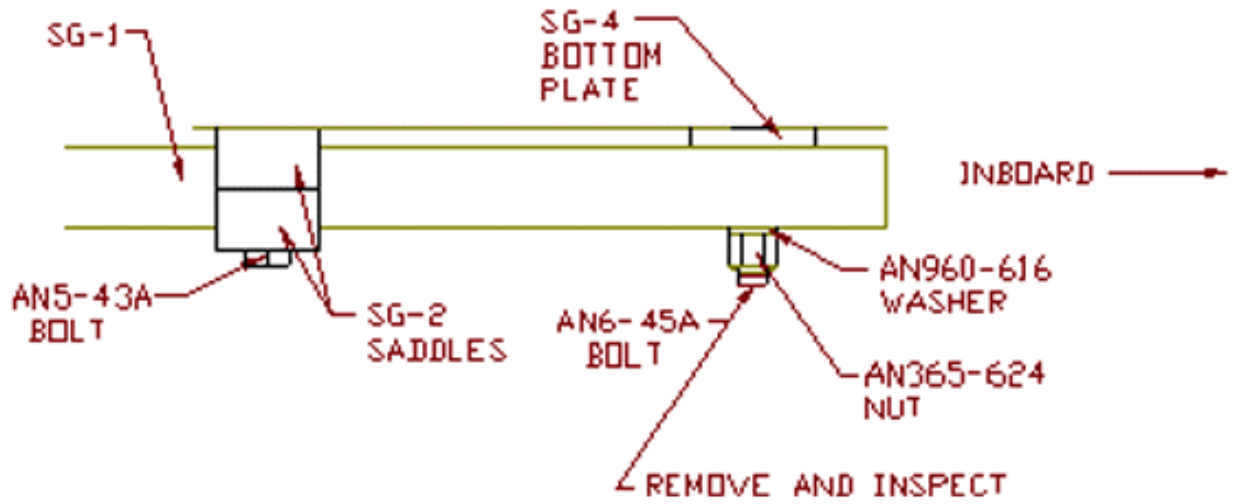
We have been notified by a Rebel customer of an incident involving the failure of the inboard Spring Gear Bolt (AN6-45A) after only 50 hours of service. The customer tells us that the inboard Spring Gear Bolt on one side of the aircraft failed to the breaking point while the inboard Spring Gear Bolt on the other side of the aircraft was found, upon inspection, to have been stretched and bent.

We have received the broken bolt from the customer and we have sent it to a lab for further analysis. We believe this failure to be an isolated case but we would like you to check your inboard Spring Gear bolts for any signs of failure as a precautionary measure. We would appreciate it if you could please inform us of your findings one way or the other. Respond to the above address by phone or fax, or send e-mail to [murtech@murphyair.com](mailto:murtech@murphyair.com).

\* When re-attaching the bolts remember to tighten to the specified torque value of 13 - 16 ft.\*lb.
