Murphy Aircraft Mfg. Ltd.

SR2500 SERVICE LETTER

Attention: Super Rebel
Subject: SR-2500 SERVICE LETTER

NOTIFICATION OF IMPENDING LANDING GEAR MODIFICATION

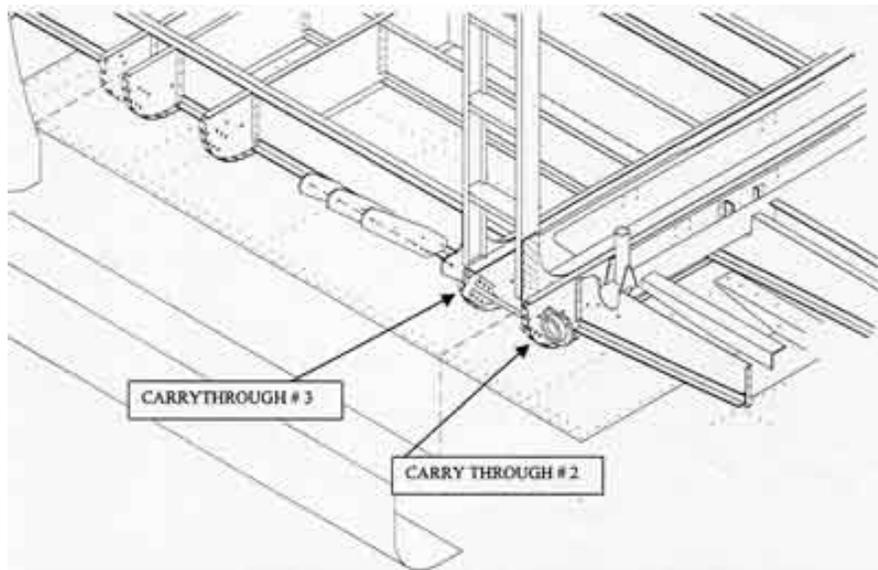
During an extensive strip down of Super Rebel Proto-type number one, cracking of the 90 degree lugs of carry throughs "2" and "3" which form the undercarriage "Box", was discovered. This appears to be caused by drag loads and results in minor gear movement during braking.

The same problem is starting to show itself on Proto-type number two and as a result we are working on a modification to cure the problem.

Builders who have not as yet permanently installed their sills are advised to delay this stage until the modification is available.

Builders who have passed this point will be issued with instructions to install the modification with minimum disruption of the structure.
