Service Bulletin; Oct, 10, 05.

Aircraft Affected; Moose, Super Rebel

Area; Outboard end of the aileron torque tube in the wing.

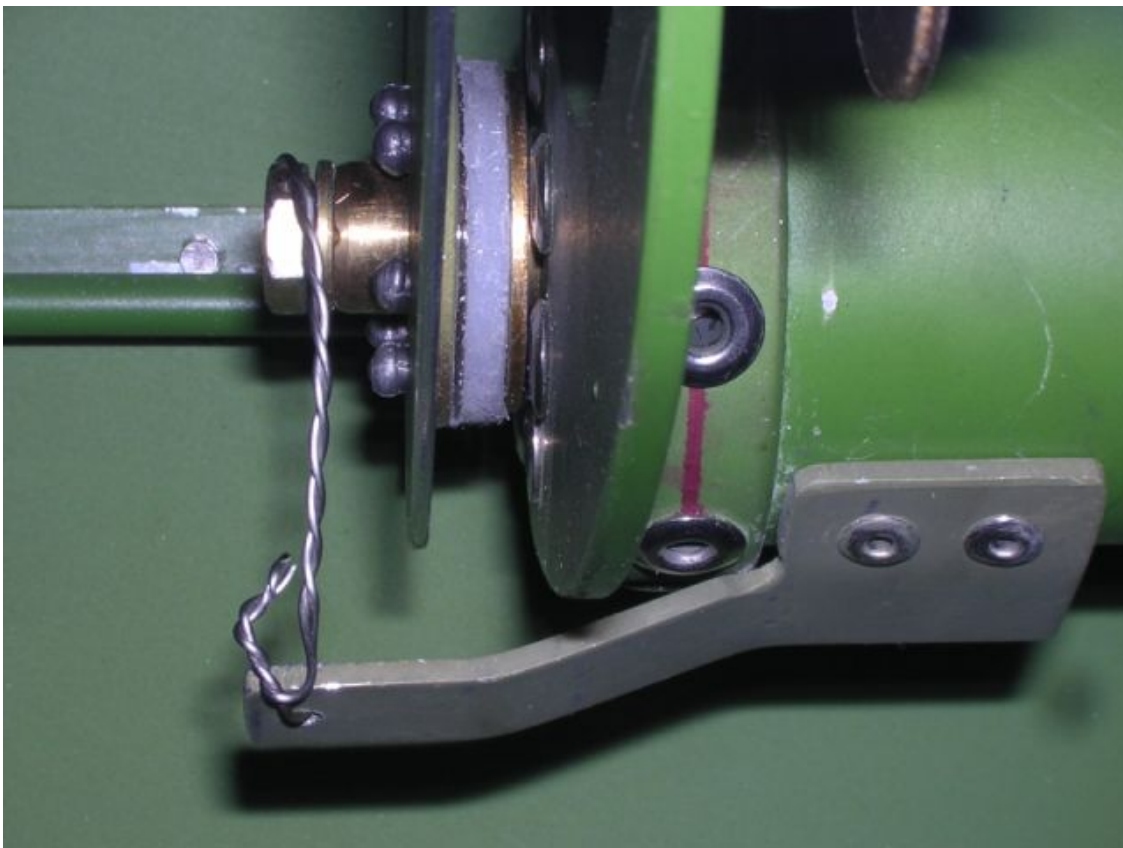
It has been brought to our attention that the AN4-13A bolt that serves to attach the aileron torque tube to the torque tube attach bracket, W0542, should be a drilled head

There are no known cases of this bolt loosening and the chance is remote as two separate bearing points would have to seize for this bolt to start to turn as well as overcome the locking feature of the anchor nut.

However it is a rotating surface and therefore should be safety wired.

Bolt, AN4H-13A and the head should be safety wired, see attached photo.

All the brass and steel bushings must be lubricated with a mild lubricant such as white lithium or LPS2.
