SAFETY BULLETIN

SR001280502

AIRCRAFT AFFECTED: SUPER REBEL 2500 and 3500

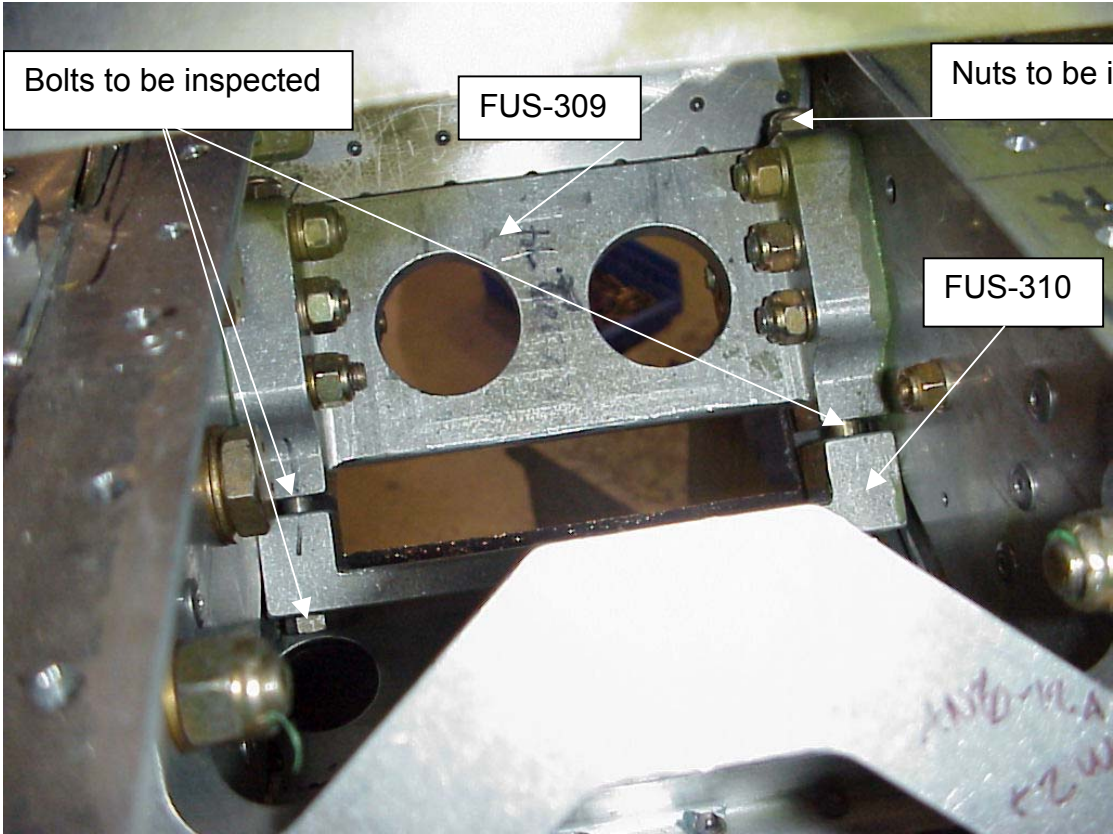
Initial inspection appears to indicate the nyloc nut on the front 5/16 bolt (AN5-44A) stripped and became detached. This bolt is one of two that clamp the FUS-309 (FUS-705 in the 3500) to the FUS-310.

Bolts to be inspected

FUS-309

Nuts to be inspected

FUS-310

Before further flight, the affected area and all gear attach bolts should be inspected. Remove the gear box covers, check all nuts are in safety and correctly torqued (100 to 140 inch pounds).
