Wing Tip Service Bulletin

Date: Friday November 19, 2004

To: All Super Rebel/Moose series owners

Re: Wing tip rib/rear spar

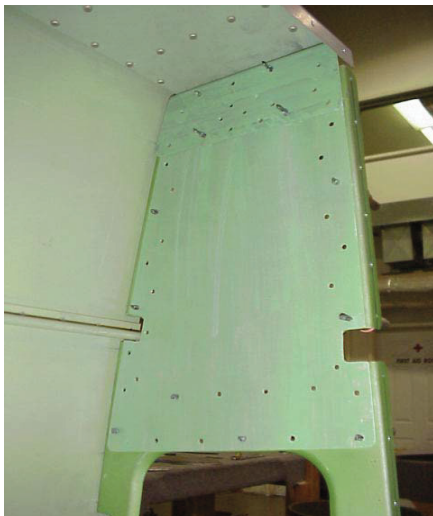
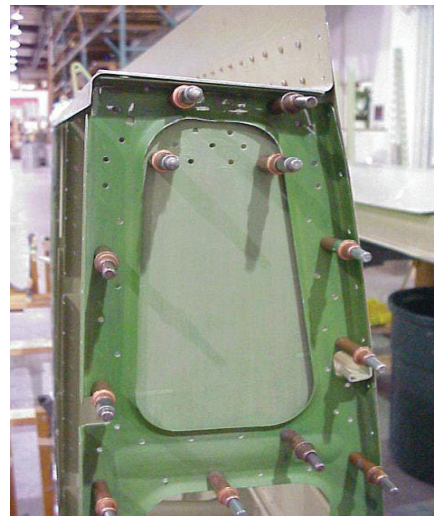
3/ Trim the ALUMINUM DOUBLER to fit one eighth of an inch inside the radius of the rib flanges to prevent cracking along the flanges. Make sure you cut out the stringer slots and LATER you will trim the trailing edge for the STEEL DOUBLER fitting. The ALUMINUM DOUBLER must be fit on the flat side of the rib because everything sits flat this way. [this means that on your left wing the mod will be on the outside and on the right wing it will be on the inside!)

4/ Once the ALUMINUM DOUBLER is trimmed layout a rivet pattern similar to the drawings provided. IMPORTANT: as you can see from the photos the STEEL DOUBLER is incorporated with the ALUMINUM DOUBLER so you must be very careful when laying the rivet pattern out. The rivets used in this mod are a one eighth rivet so you need a quarter of an inch edge distance for EVERYTHING! Start by drilling #40's and leave it at that for now.

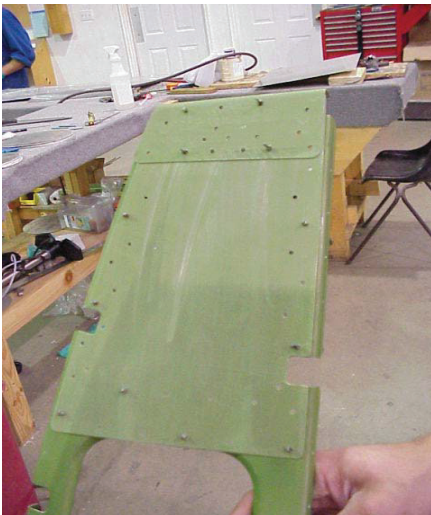
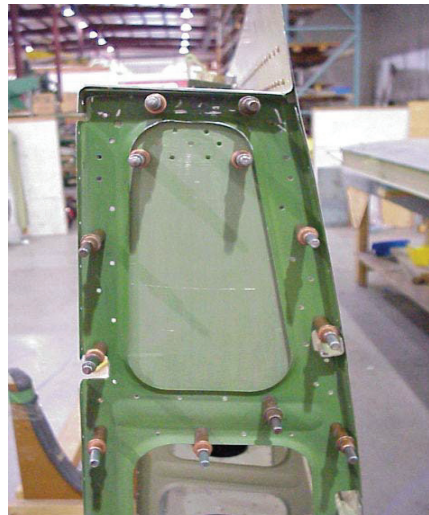
5/ Now pick up the STEEL DOUBLER and trim it to fit as the new rib flange. Trim it so it stays clear of the rear spar radiuses but if you trim too much you will have no edge distance for your hinge bracket bolts! Cleco the skin [top and bottom] back onto the tip rib to ensure great alignment. Next fit the STEEL DOUBLER to the ALUMINUM DOUBLER making sure the new rib flange has a perfect fit to the rear spar and finish drilling to #40. You can now drill all doubler holes to #30. With everything still clecoed in place drill into the new steel flange in between the hinge bracket holes at #40 to create pilot holes to simplify drilling the steel. Cleco each hole as you go. Drill the hinge bracket holes next to #40 and when all holes are drilled finish the hinge bracket with #11 holes and the holes in between are #30.

6/ Take both doublers off and deburr. TO PREVENT CORROSION PROBLEMS YOU MUST ZINC CHROMATE BOTH DOUBLER PIECES AS WELL AS DIP EACH RIVET IN CHROMATE BEFORE INSTALLATION!! Re-cleco the doublers back onto the rib and rivet together using the ZINC CHROMATE method specified earlier. You can then reinstall the rivets in between the hinge bracket holes first, then reinstall the hinge bracket. You can now finish by riveting the skin back to the rib. Do not rivet any of this together if you have a cracked spar! Please contact us when you get to this stage for further instructions. Repeat ALL steps for other wing!
