### **SERVICE BULLETIN 022019RB**

URGENCY: HIGH  
RE: Stabilizer Struts

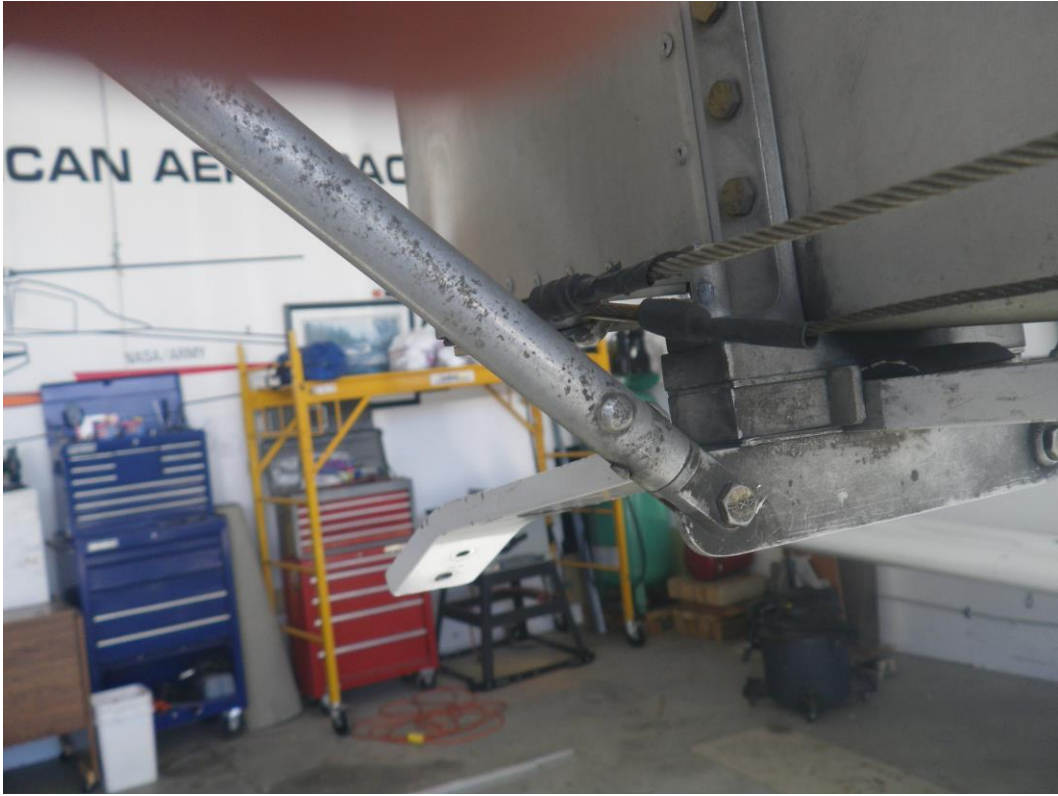
A Rebel has been found with a broken lug on one of the stabilizer strut ends (ST0041). This is the third one we are aware of.

1. Remove struts and clean.
2. Inspect the lugs carefully for cracks or other damage. Dye penetrant would be best.
3. The only way to inspect for corrosion is to disassemble.
4. Please report any damage to Murphy Aircraft.

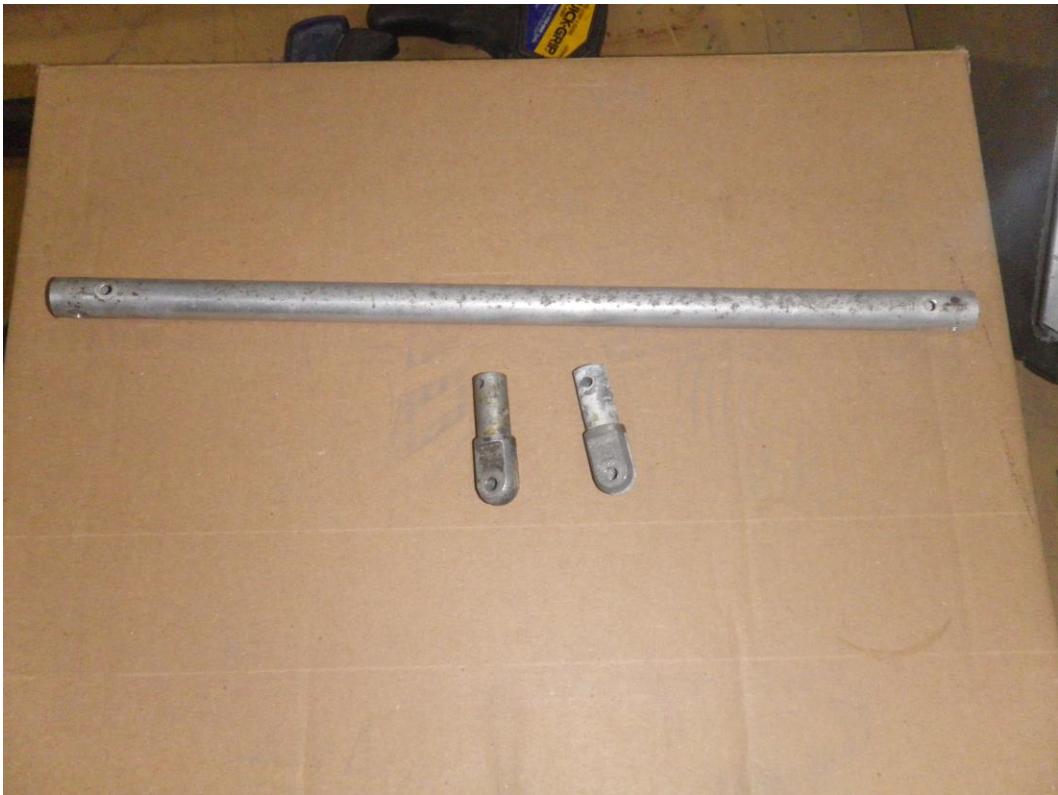
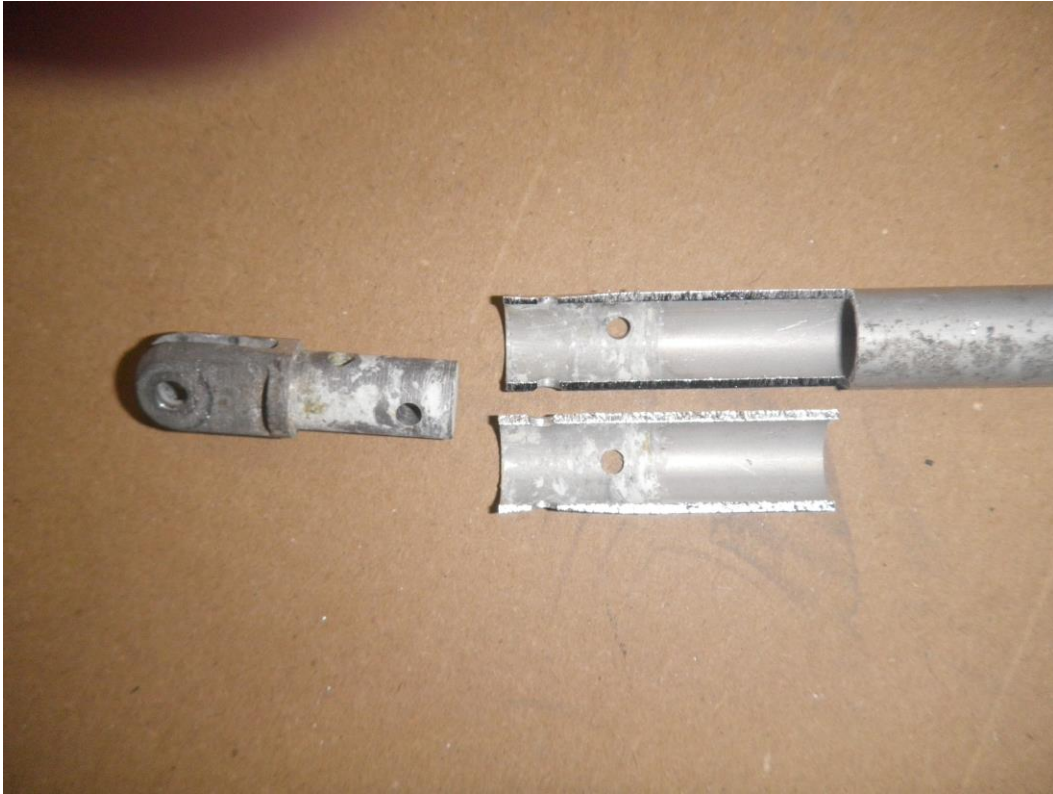
We removed the struts from a local Rebel. This Rebel has been flying for over 20 years and has 560 flight hours on it. Approximately equal time on spring gear and on Murphy 1800 amphib floats. It has never been in salt water and has always been hangered. No damage was apparent on the lugs. The right-side strut tube was pitted, picture #1, on the front side, probably from rocks and sand from landing on sand bars and gravel strips when the aircraft was on wheels. The left-side strut had no pitting. Both struts were disassembled. Corrosion was found on both ends of each strut pictures #2 & picture #3

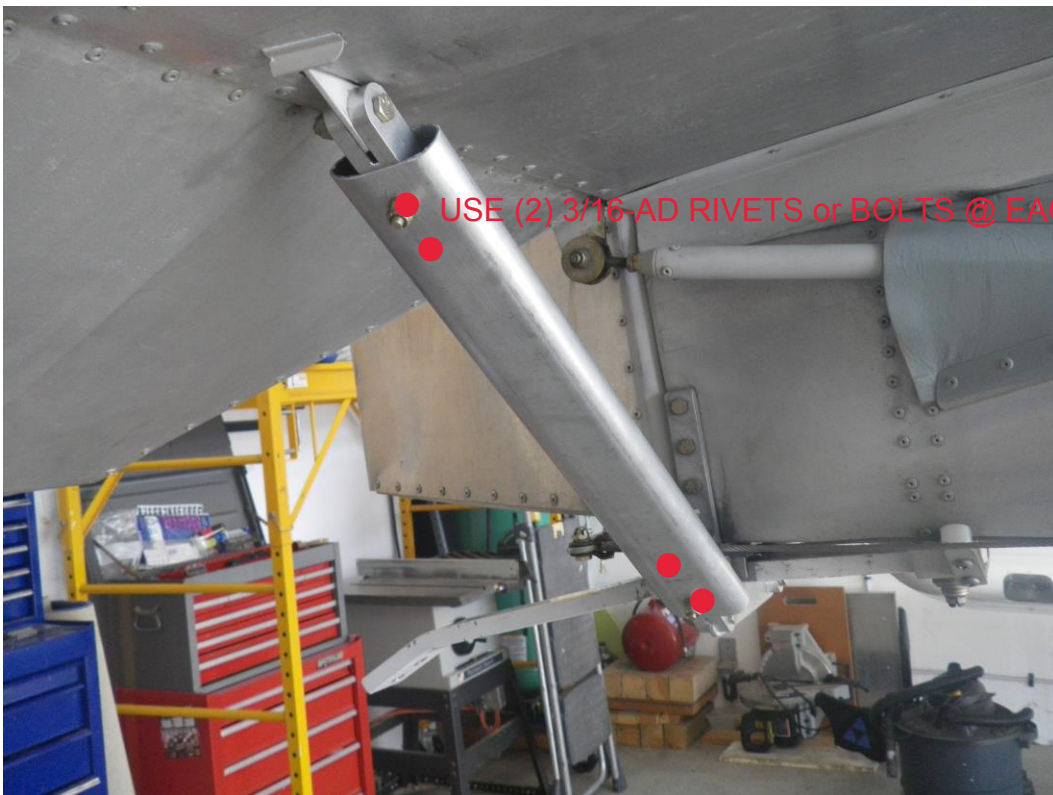
We strongly recommend upgrading to the more robust strut system as used on the RADICAL, picture #4. The upgrade kit is \$226 US plus shipping. Picture #4 shows one bolt at each end. The upgrade kits will use two solid rivets each end. Replacement time was less than one hour.

● USE (2) 3/16-AD RIVETS or BOLTS @ EACH END of STRUT
