Safety Bulletin 070595RB

Re: Rebel Seat Bracing

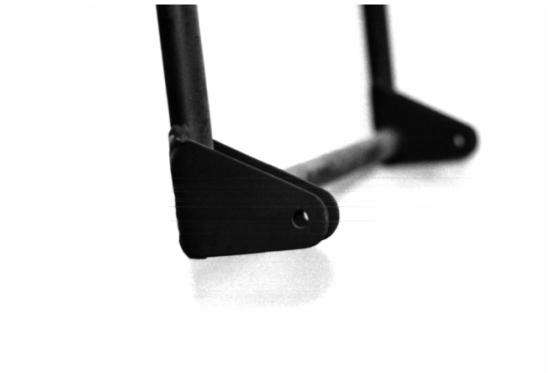
Photo #1 Old Seat Back

The early model of the seat back was braced by two welded gusset plates which also attached the seat back to the hinge bolt. (See photo# 1) Early models also had the aluminum skin riveted to the front of the frame rather than the back. This puts holes in the front of the tube which is under tension during load, therefore risking cracking or eventual failure. It is possible for this version of the seat back to fail in bending, especially depending on where holes are drilled in the tubes to attach the aluminum skin.

If Rebel owners still have the older version of the seat back. It should be modified to bring it to present specifications as shown in the attached photo. (See photo# 2) The modification is a relatively simple one including only a very few parts and the use of a TIG welder. These parts are available from the factory free of charge, for any builder who still has the old seat back. Please contact our shipping department if you require these parts and instructions.

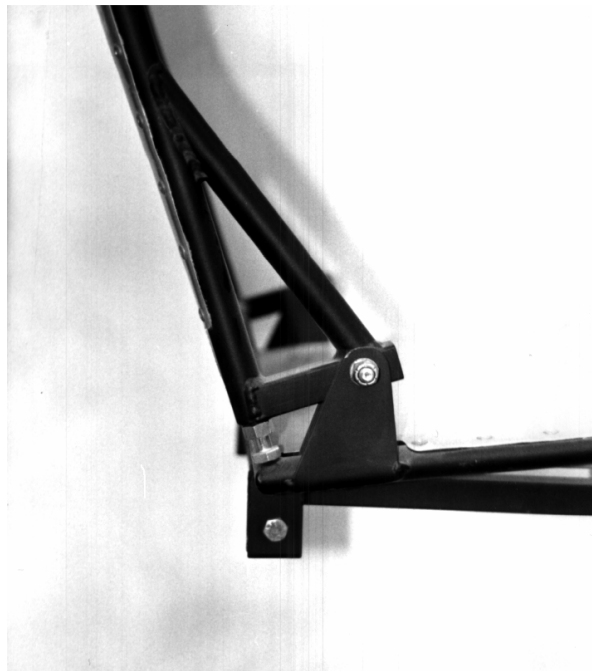
Photo #2 New Seat Back Brace

The newer seat back replaces the gusset plates with two square tubes welded diagonally. The aluminum skin is riveted to the back side of the frame. This seat back is stronger and not susceptible to breakage or bending under high stresses.

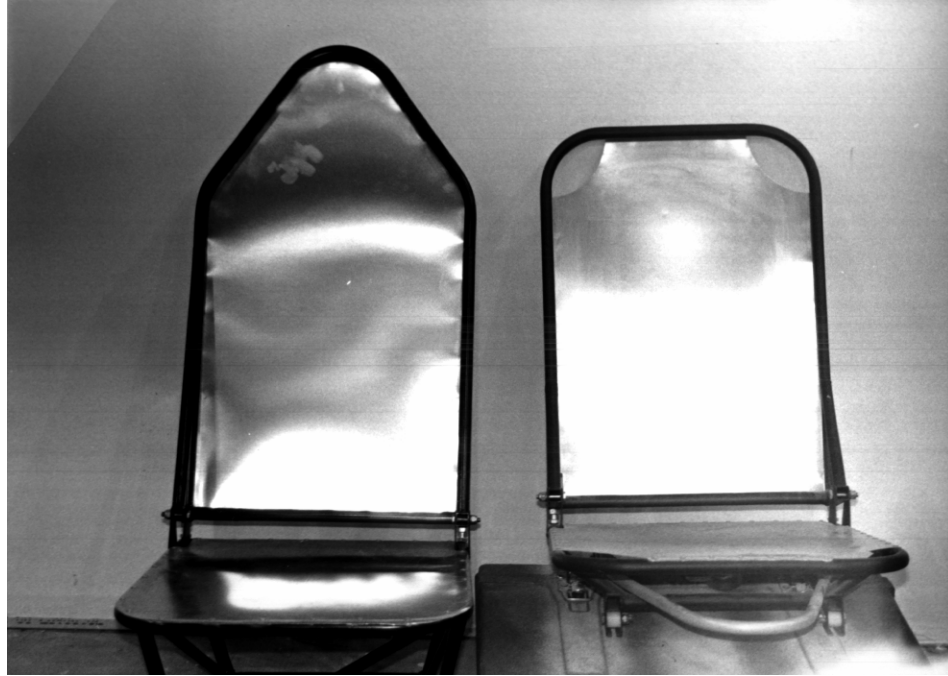
Photo #3 High Back (left) and Low Back (right)

Rebel owners also have the option of purchasing the new High Back for the seat which has recently been developed for use in the upcoming SR2500. (See photo# 3) The seat is extremely strong and of similar design to that of the updated Rebel seat, but also offers a high back for additional comfort and support. If you are interested in purchasing a high back seat, please contact our sales department.
